Mobile Intel® Celeron® Processor on 0.13 Micron Process in Micro-FCPGA Package

Specification Update

February 2007

Document Number: 251309-029

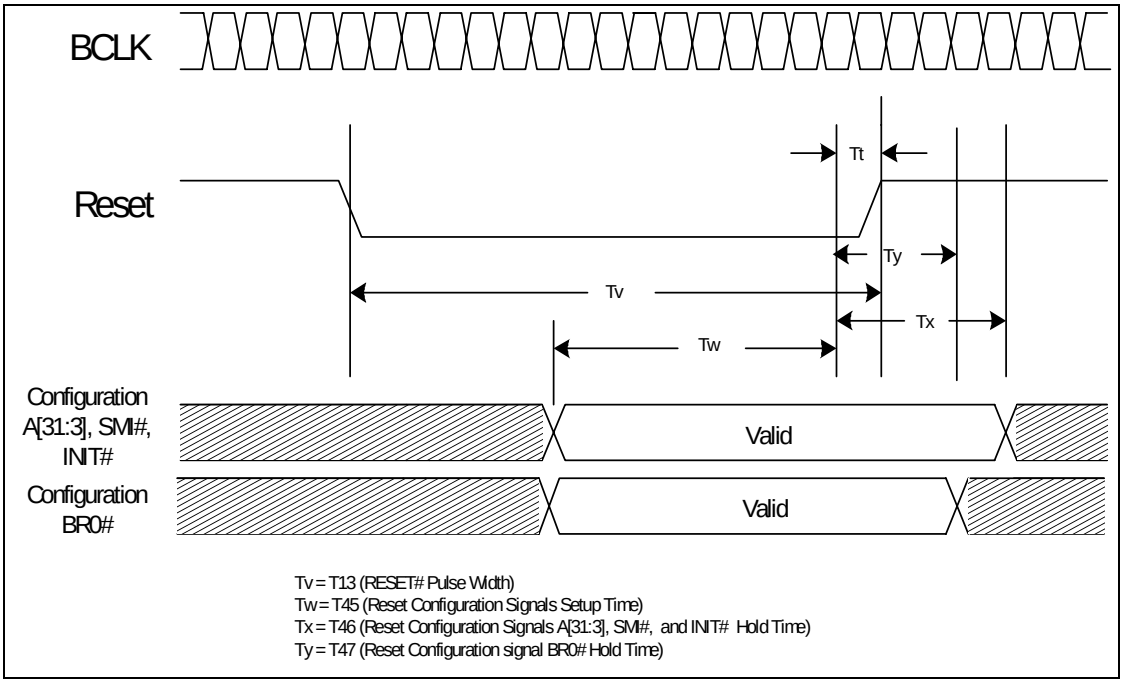
Figure 12. System Bus Reset and Configuration Timings

The BR0# maximum hold time has changed to 2 BCLKs. This change will be shown in the "System Bus AC Specifications (Reset Conditions)" table and "System Bus Reset and Configuration Timings" figure of the *Mobile Intel® Celeron® Processor on .13 Micron Process in Micro-FCPGA Package Datasheet.* This change will be incorporated in the next revision of the datasheet.

The following figure will be modified to reflect this change:
